7.3L FORD DIESEL TRUCK FROM 5/87-1994

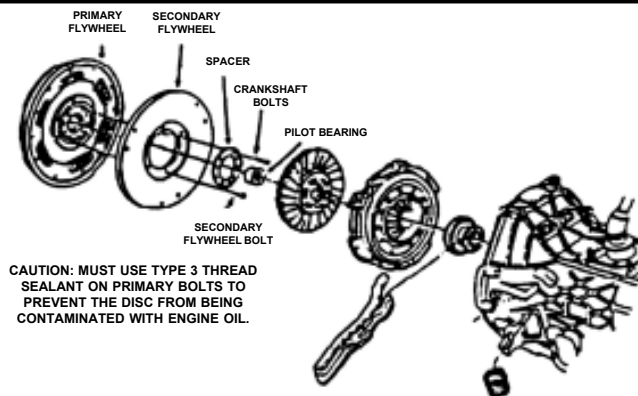
THE TRANSMISSION INPUT SHAFT BEARING RETAINER COLLAR MUST BE FREE OF WEAR, GALLING OR GROOVES. IF THE COLLAR IS NOT IN GOOD CONDITION, IT MUST BE REPLACED. A WORN RETAINER COLLAR CAN CAUSE THE CLUTCH TO HAVE AN ERRATIC ENGAGEMENT AND HIGH PEDAL EFFORT.
